SECTION 32 PROGRAM
STREAMBANK EROSION CONTROL
EVALUATION AND DEMONSTRATION
WORK UNIT 4 - RESEARCH ON SOIL STABILITY AND
IDENTIFICATION OF CAUSES OF STREAMBANK EROSION

EVALUATION OF RIGID AND FLEXIBLE
MATERIALS FOR BANK PROTECTION

by
Clarence R. Styron III

May 1979
Investigation Report 2

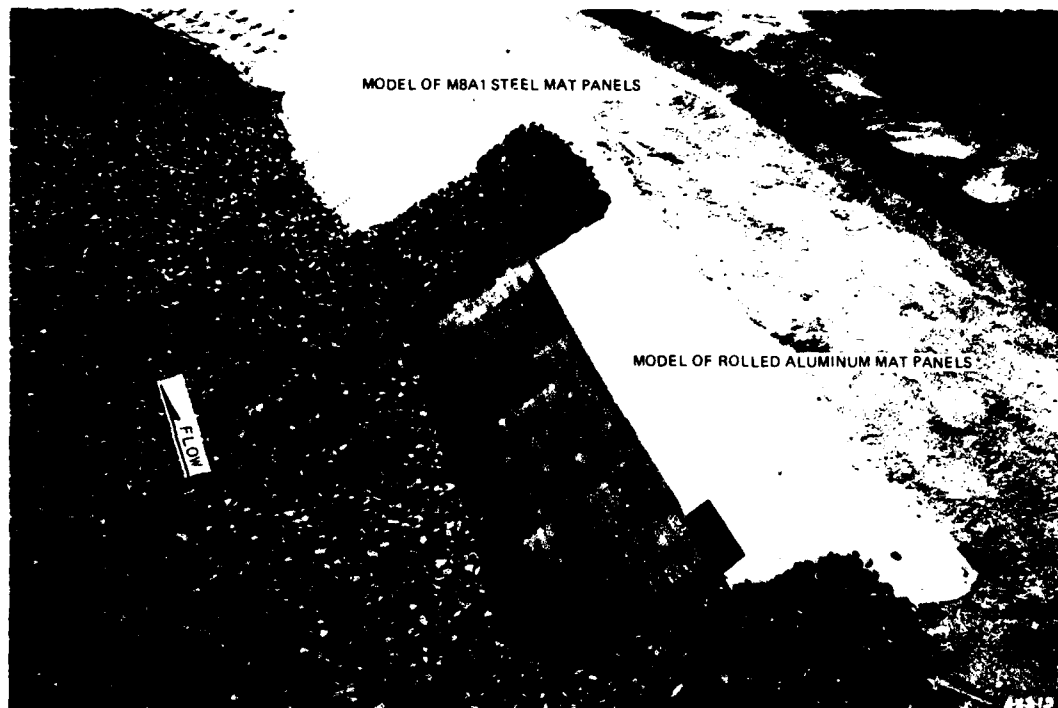
Photo 1. Model of rolled aluminum mat panels (bottom center) and M8A1 landing mat (top center) prior to first test. Filter cloth shown is along top edge only

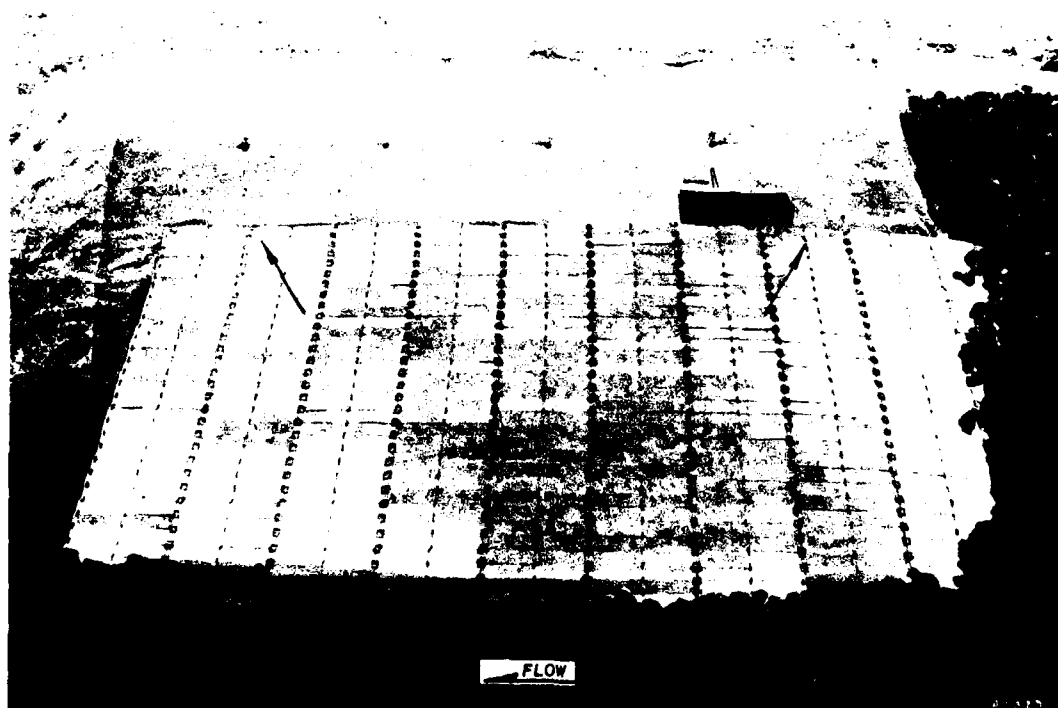
Photo 2. Model M8A1 steel mat panels (anchors loosened at arrows)

7. During the $0.31\text{-m}^3/\text{sec}$ (11-cfs) flow, the water overtopped the aluminum sheets that simulated the M8A1 steel mat panel and fluctuated above and below the uppermost edge of the section. After the flow of $0.31\text{ m}^3/\text{sec}$ (11 cfs) for 1 hr, the flume was drained and the sections inspected. It was noted that several anchors along the upper edge of the section simulating the M8A1 mat panel had worked loose and risen above the surface (Photo 2). The sheets that simulated the rolled aluminum mat panel showed definite signs of movement as the last three rows of anchors had worked loose and sand had been eroded from an area approximately 15 cm (6 in.) above the toe and deposited near the edge of the lower end of the section in a mound approximately 2.5 cm (1 in.) high (Photo 3).

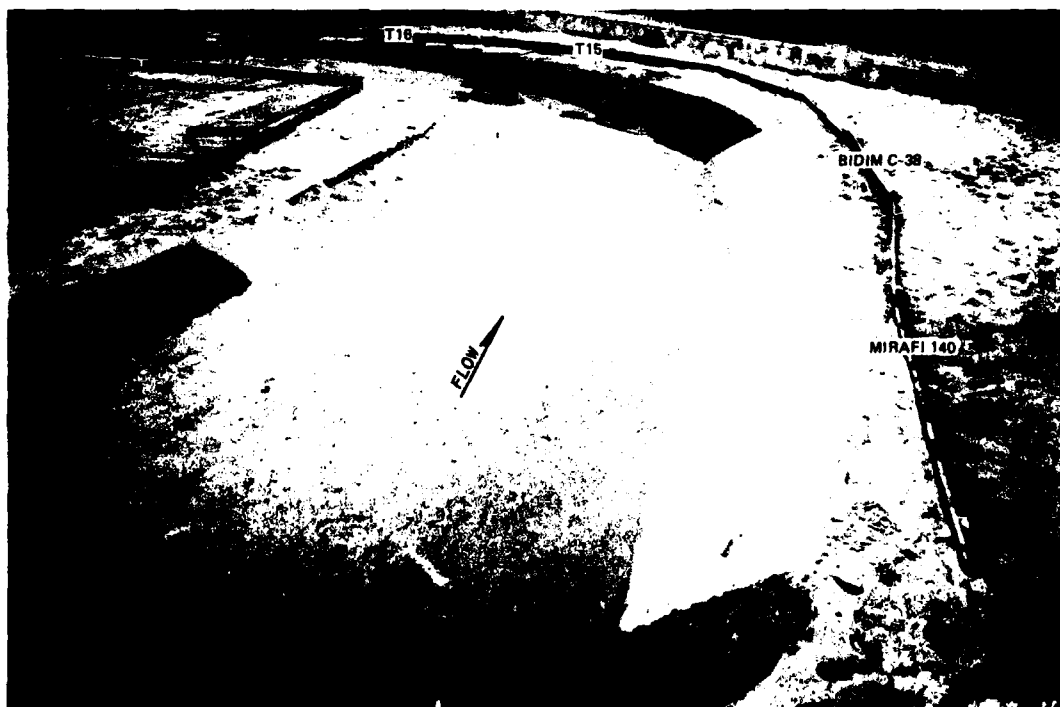
Photo 6. T16, T15, Bidim C-38, and Mirafi 140 during initial tests

9. Seven membranes were placed along the streambank in the test flume on sand slopes of 1 vertical to 2 horizontal and subjected to various flows. Mirafi 140, Bidim C-38, T15, and T16 (Photo 6) were initially placed in the model at points 7, 8, 9, and 10, respectively (see Figure 1). These membranes were subjected to flow up to $0.23 \text{ m}^3/\text{sec}$ (8 cfs). After 1 hr at $0.23 \text{ m}^3/\text{sec}$ (8 cfs), the model was shut down for required maintenance elsewhere; therefore, the bank beneath the membranes was inspected (Photos 7 and 8). Since no visible damage had occurred to the slopes protected by any of the membranes, it was decided to remove two of the heavier membranes, T15 and T16, and replace them with two lighter membranes, Griff Weave 10 and Griffolyn Type 55. Flows were again initiated. After 1 hr at $0.20 \text{ m}^3/\text{sec}$ (7 cfs), air bubbles accumulated in the Griffolyn Type 55, especially at the downstream end, and ballooning was also noted at the top of Griff Weave 10. At $0.23 \text{ m}^3/\text{sec}$ (8 cfs), ballooning was noted in the Griffolyn Type 55.

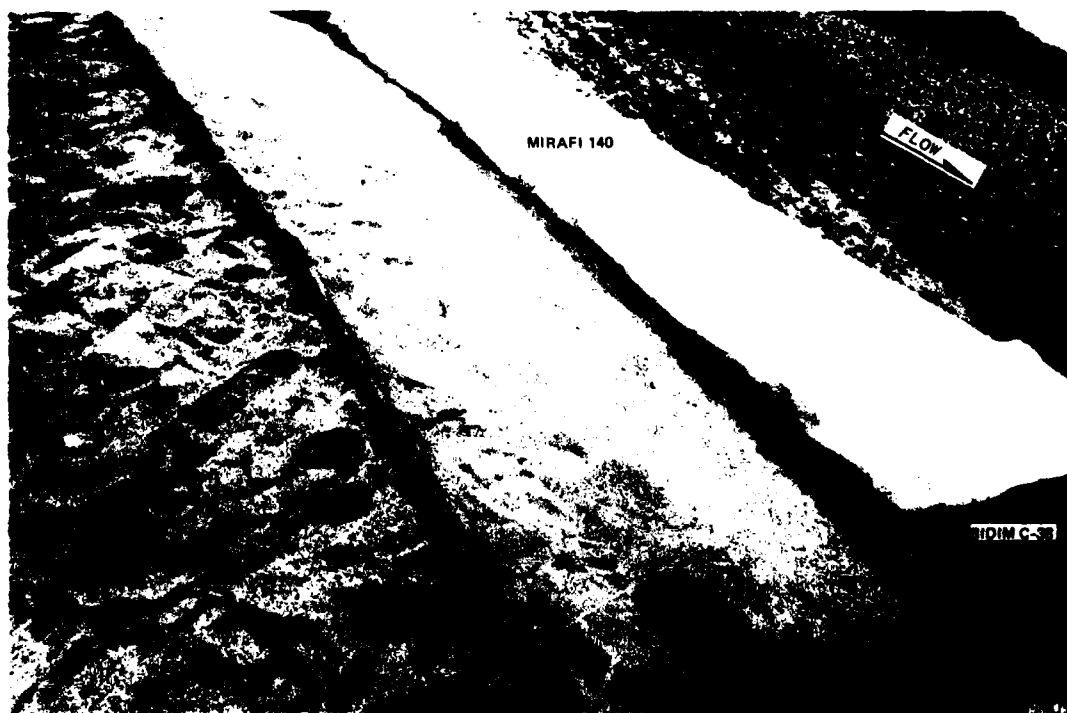
Photo 8. Sand condition beneath Bidim C-38 and Mirafi 140 following $0.23 \text{ m}^3/\text{sec}$ (8 cfs)

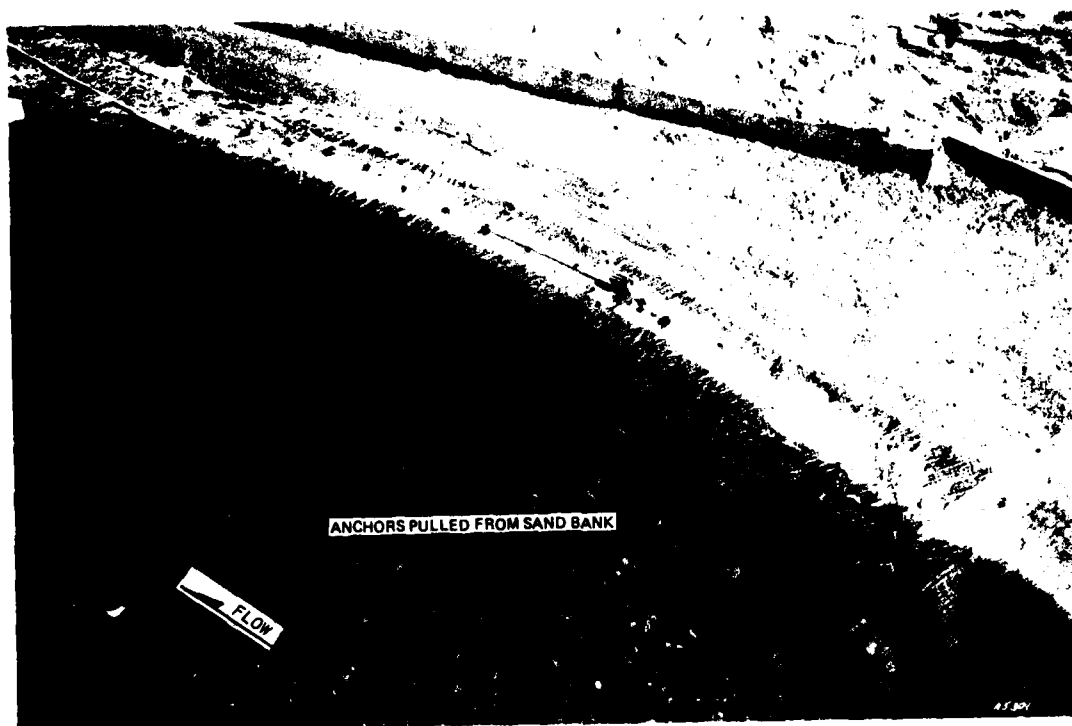
Photo 9. Griffolyn Type 55 anchored on 15-cm (6-in.) centers following $0.28 \text{ m}^3/\text{sec}$ (10 cfs)

10. To reduce and/or eliminate ballooning, it was decided to anchor the Griffolyn Type 55 and Griff Weave 10 membranes. This was accomplished by forcing 8.6-cm-(3-3/8-in.-) long nails through the membranes into the sand bank at 15-cm (6-in.) intervals both parallel and perpendicular to the direction of flow. Flow was resumed at $0.25 \text{ m}^3/\text{sec}$ (9 cfs) and increased to $0.28 \text{ m}^3/\text{sec}$ (10 cfs), at which point the nails in the Griffolyn Type 55 membrane were completely pulled from the sand but remained lodged in the membrane (Photo 9). Nails in the Griff Weave 10 had some of the shaft exposed in varying amounts indicating some uplift (Photo 10). Griffolyn Type 55 and Griff Weave 10 were removed from the model, and the bank was inspected. Erosion and movement of the underlying sand were not in evidence. These membranes were replaced by a membrane designated as Sackurity Bag. Flow was then initiated at $0.20 \text{ m}^3/\text{sec}$ (7 cfs) and increased gradually to $0.34 \text{ m}^3/\text{sec}$ (12.5 cfs), the maximum discharge of this model. Minute erosion and movement of sand were found under the Sackurity Bag (Photo 11).

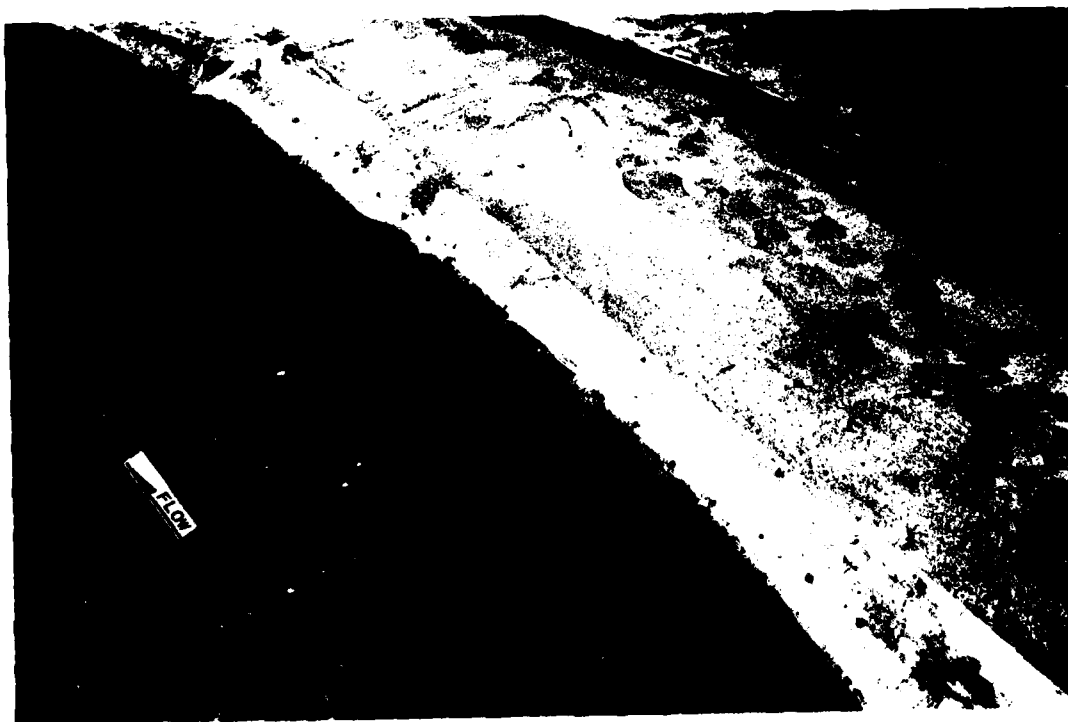
Photo 10. Griff Weave 10 anchored on 15-cm (6-in.) centers following $0.28 \text{ m}^3/\text{sec}$ (10 cfs)

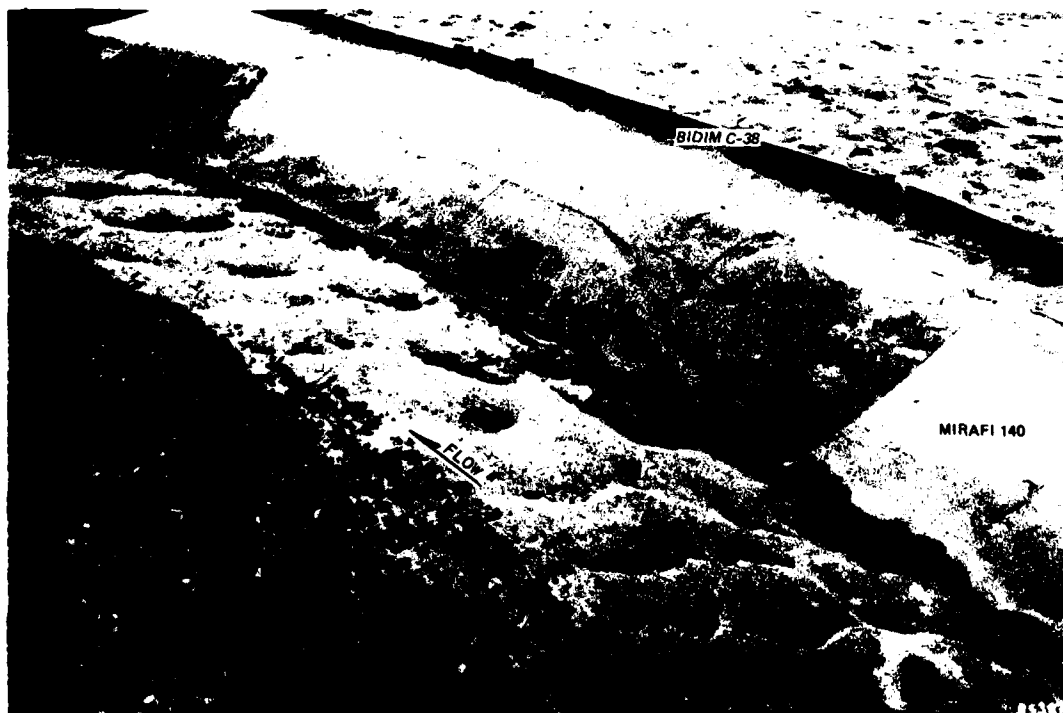
Photo 12. Bidim C-38 following $0.34 \text{ m}^3/\text{sec}$ (12.5 cfs)

11. The membranes, Bidim C-38 and Mirafi 140, successfully sustained the maximum flow of $0.34 \text{ m}^3/\text{sec}$ (12.5 cfs) (Photos 12 and 13); however, these materials were not placed in the bendway but parallel to the direction of flow as shown in Photo 14. These test materials also served to protect the streambank along this section of the model where sufficient rock was not available for protection. Air bubbles were visible beneath these materials, and small pockets of sand had accumulated beneath the Bidim C-38 and Mirafi 140 (Photo 15).

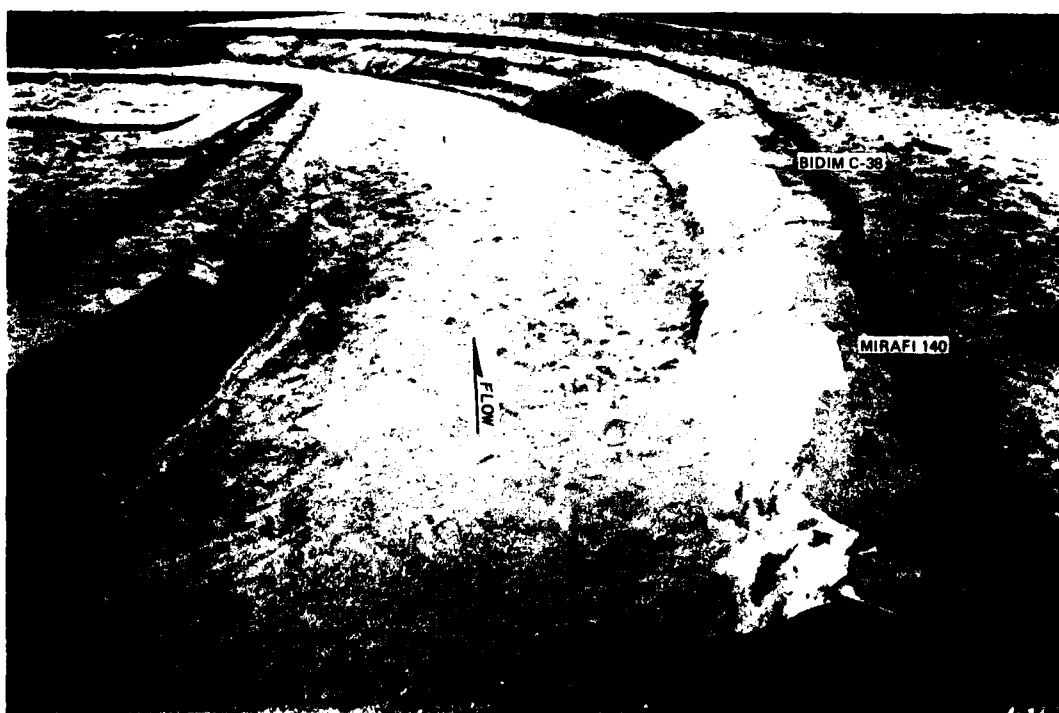
Photo 14. Bidim C-38 and Mirafi 140 following $0.34 \text{ m}^3/\text{sec}$ (12.5 cfs)

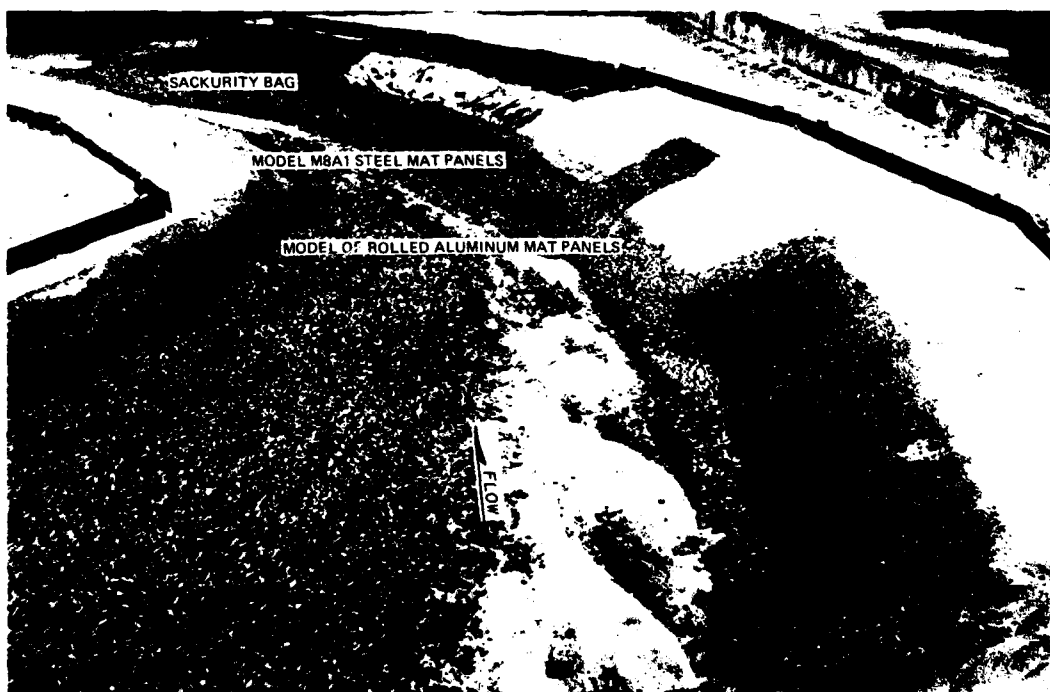
Photo 16. General view of metal test materials and Sackurity Bag following $0.34 \text{ m}^3/\text{sec}$ (12.5 cfs)

12. A variety of materials were subjected to various model flow conditions that simulated the effects that streams produce normally when flowing at or near maximum stages (Photo 16). For the scaled rigid materials, a linear scale between the model and the prototype of 1:25 was realized; however, the membrane materials scaling factor was 1:1. Nevertheless, the conditions produced by model flows on membrane materials did provide indications of conditions that may develop and/or subsequently occur when these materials are used on streambanks.
